Design Proposal • June 24, 2020
117 East Union Street
Morganton, North Carolina

Design Proposal

115 and 117 East Union St
Morganton, NC

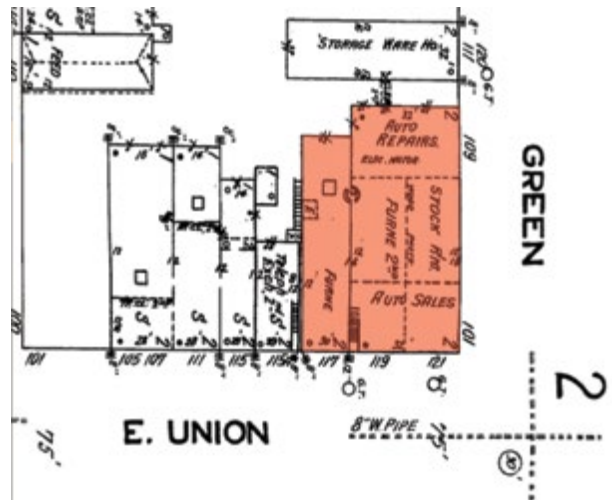
Sanborn Map, 1924

Sanborn maps reveal that building 115 housed a furniture store in 1924, a paints & oils store in 1931, and a furniture store again in 1950. Building 117 initially housed a Ford car dealership then operated as Lazarus, a high-end clothing store for men and women until 1940.

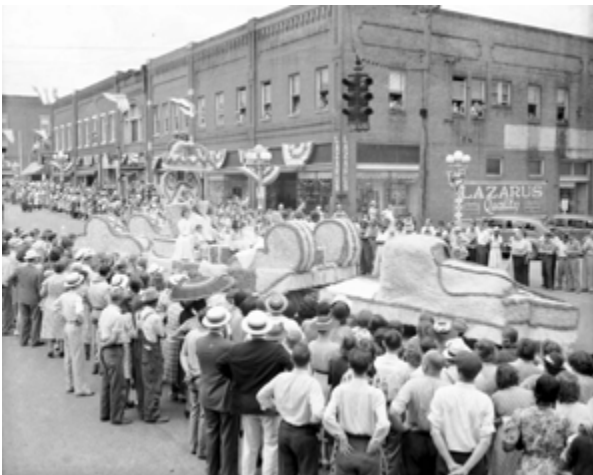
1940

Our research revealed that while the upper story architecture remains intact, the storefront bays have been altered at least three times over the years as evidenced by historic photos and Sanborn Maps. One of the most impactful changes occurred in the 1980s when the center pilaster at unit 117 was removed at the lower level and replaced by a pseudo 3 centered arch canopy supported by brick columns. Other significant changes include bricking in windows on the N Green Street facade, including most of the display window at the southeast corner and all of the lower level windows below the transoms. In the earliest photo the storefront transoms appear to be clear plate glass but in the 1940s photo leaded & beveled glass transoms can be seen.

For 117 E Union Street, remove existing awning and its related hardware and fasteners above the storefront. Remove the later canopy structure and storefront as well as the bricked-in portion of the display window on the side facade. Reconstruct the center pilaster as shown in the 1940s photo.

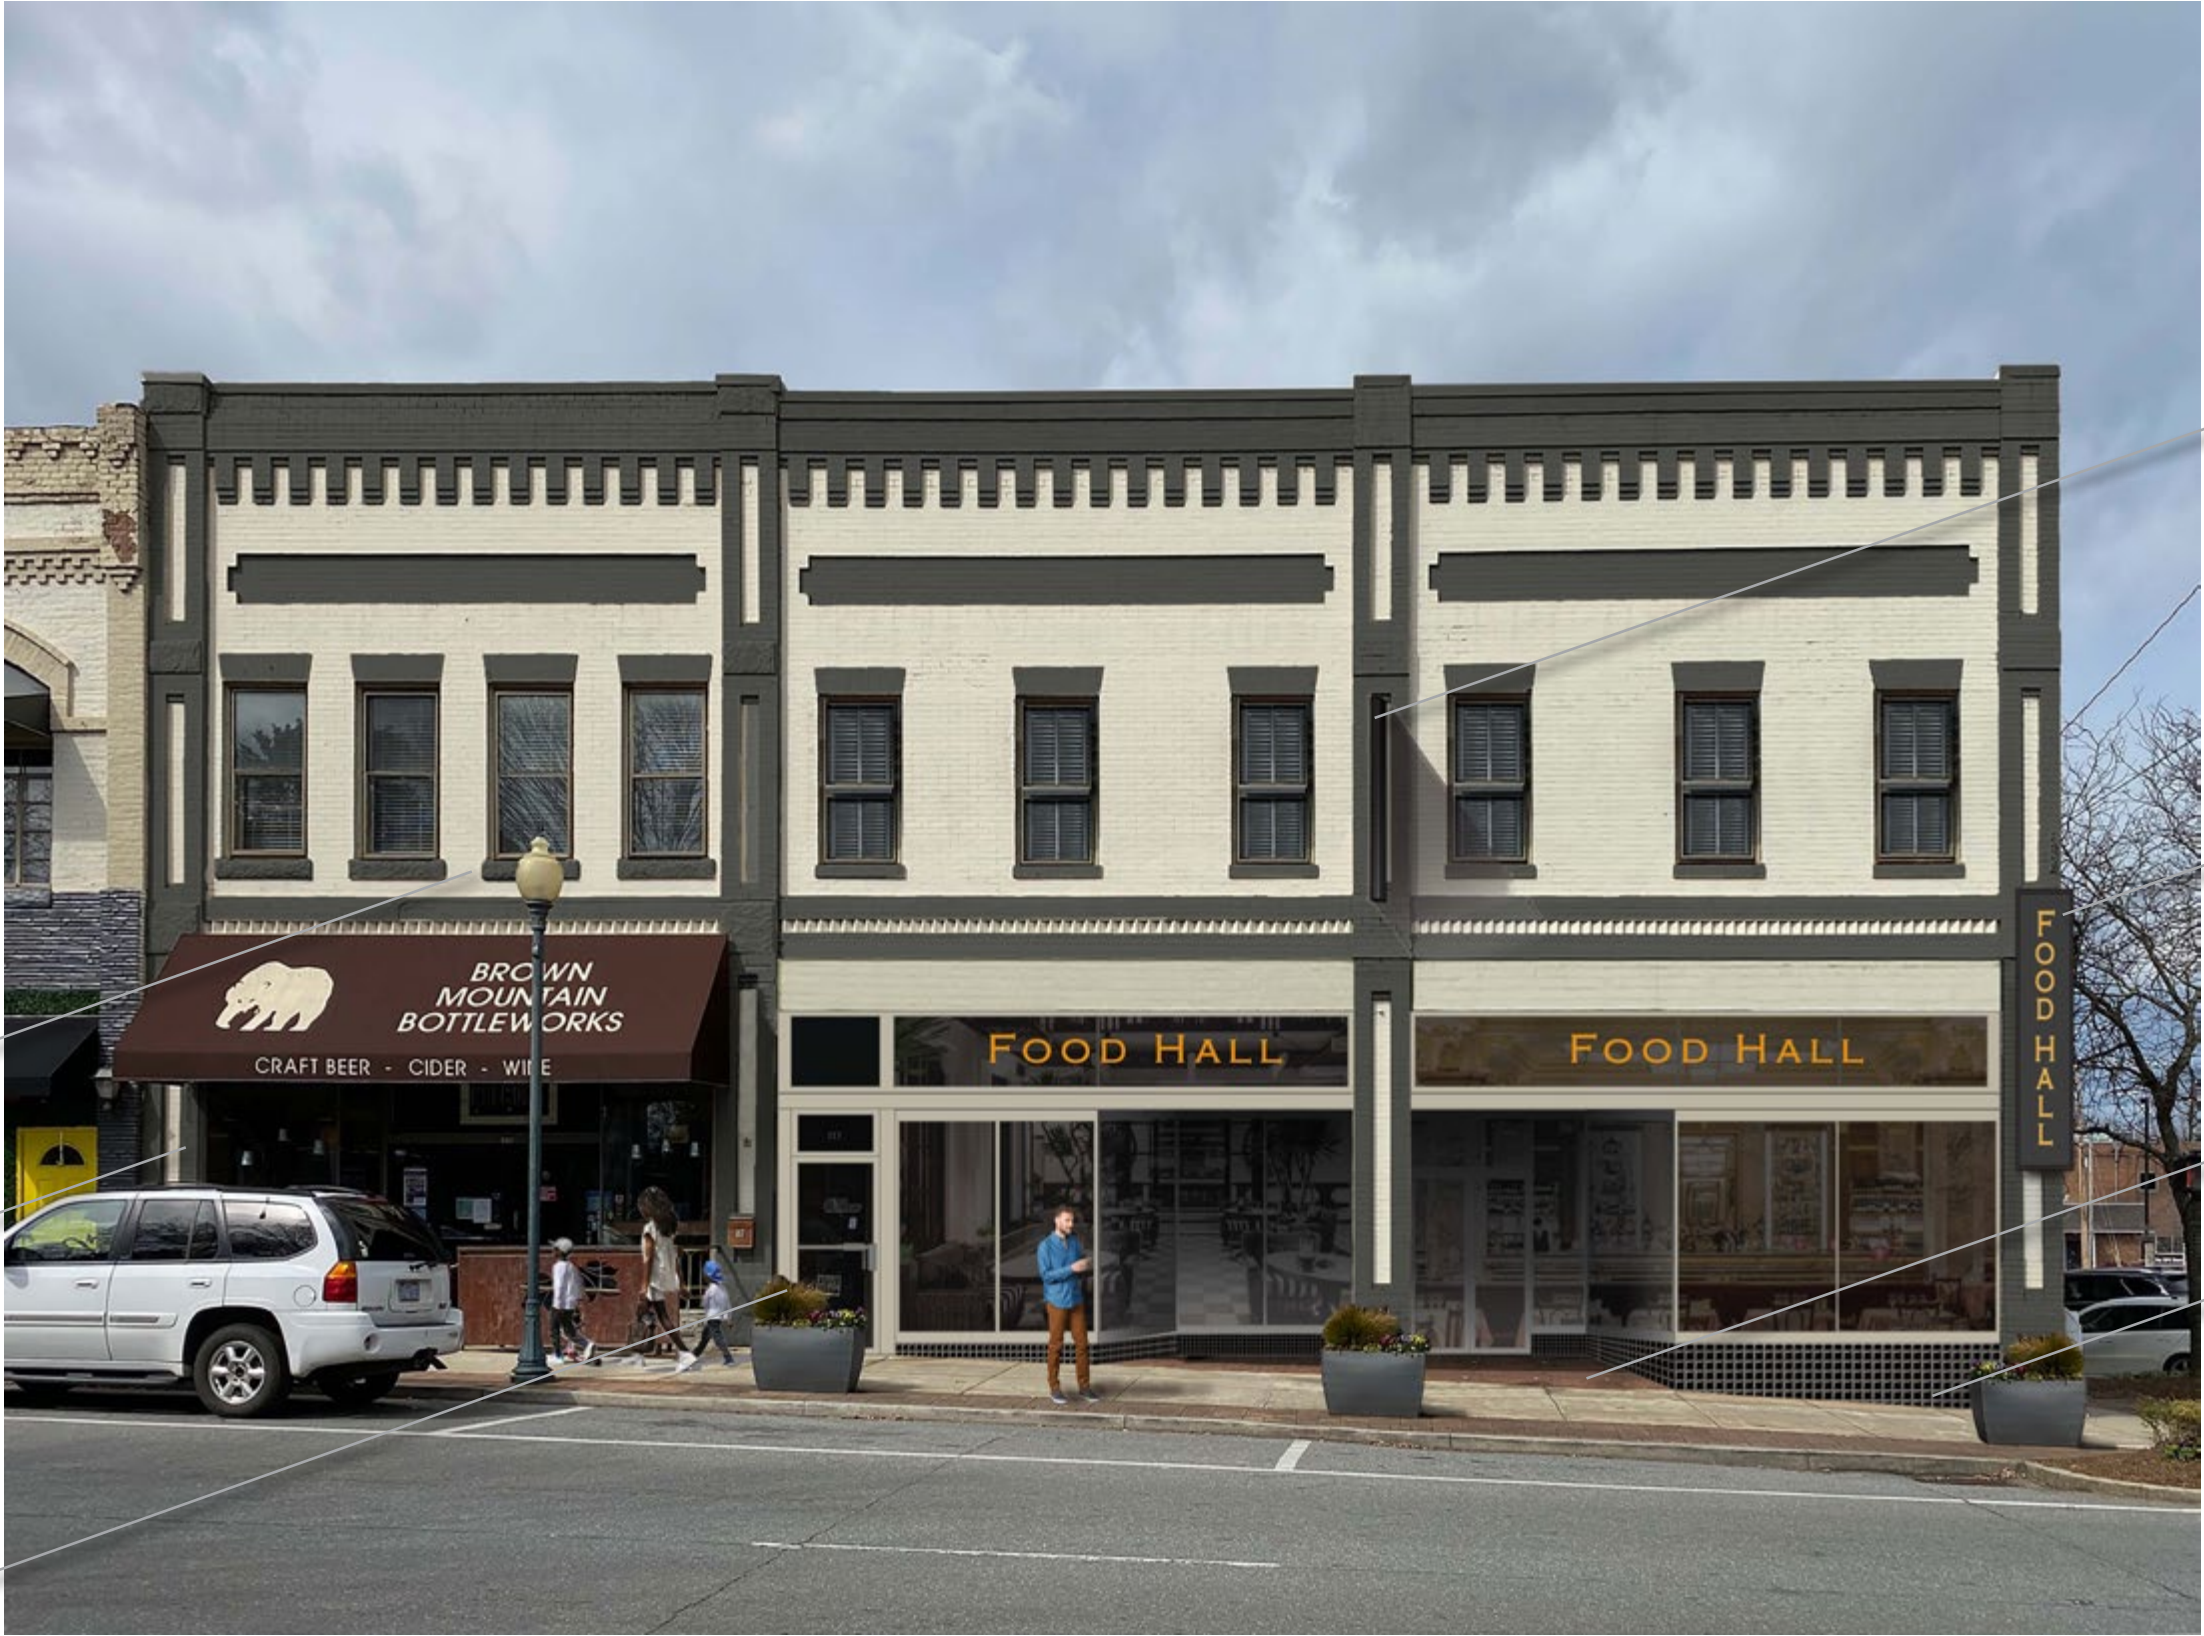
Design Scheme 1

SW 7011 Natural Choice
SW 7069 Iron Ore

Brick Body of Facade
Brick Architectural Features
Wooden Window Surrounds and Sashes
Wooden Elements of Storefront

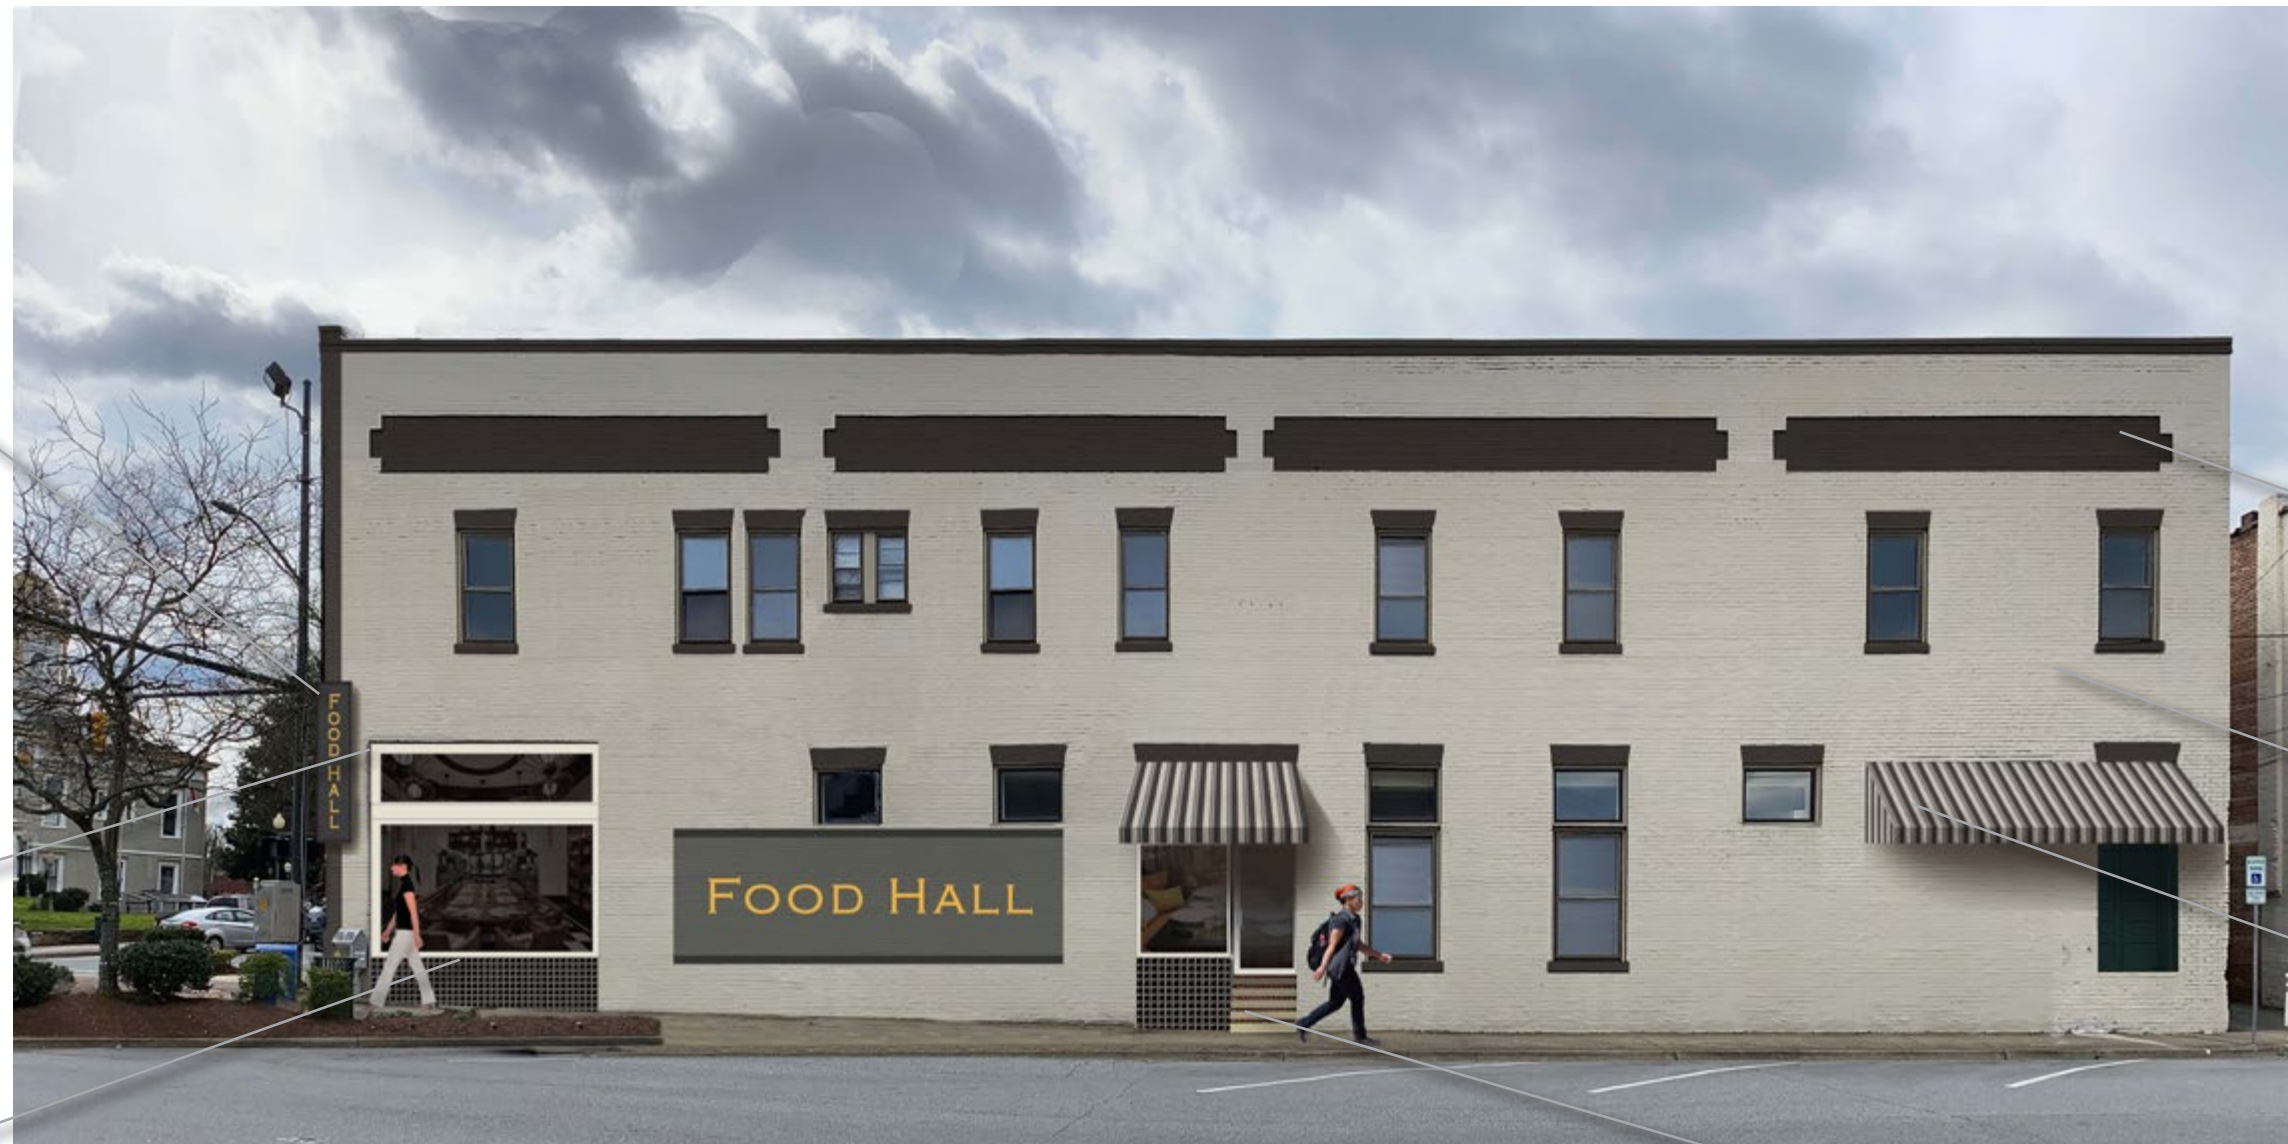
Bulkhead Tiles

Body Pattern: SP8126 and the recommended border pattern is SB 1107, both from Daltile Pattern Guide. Copy and paste the following link into a browser:

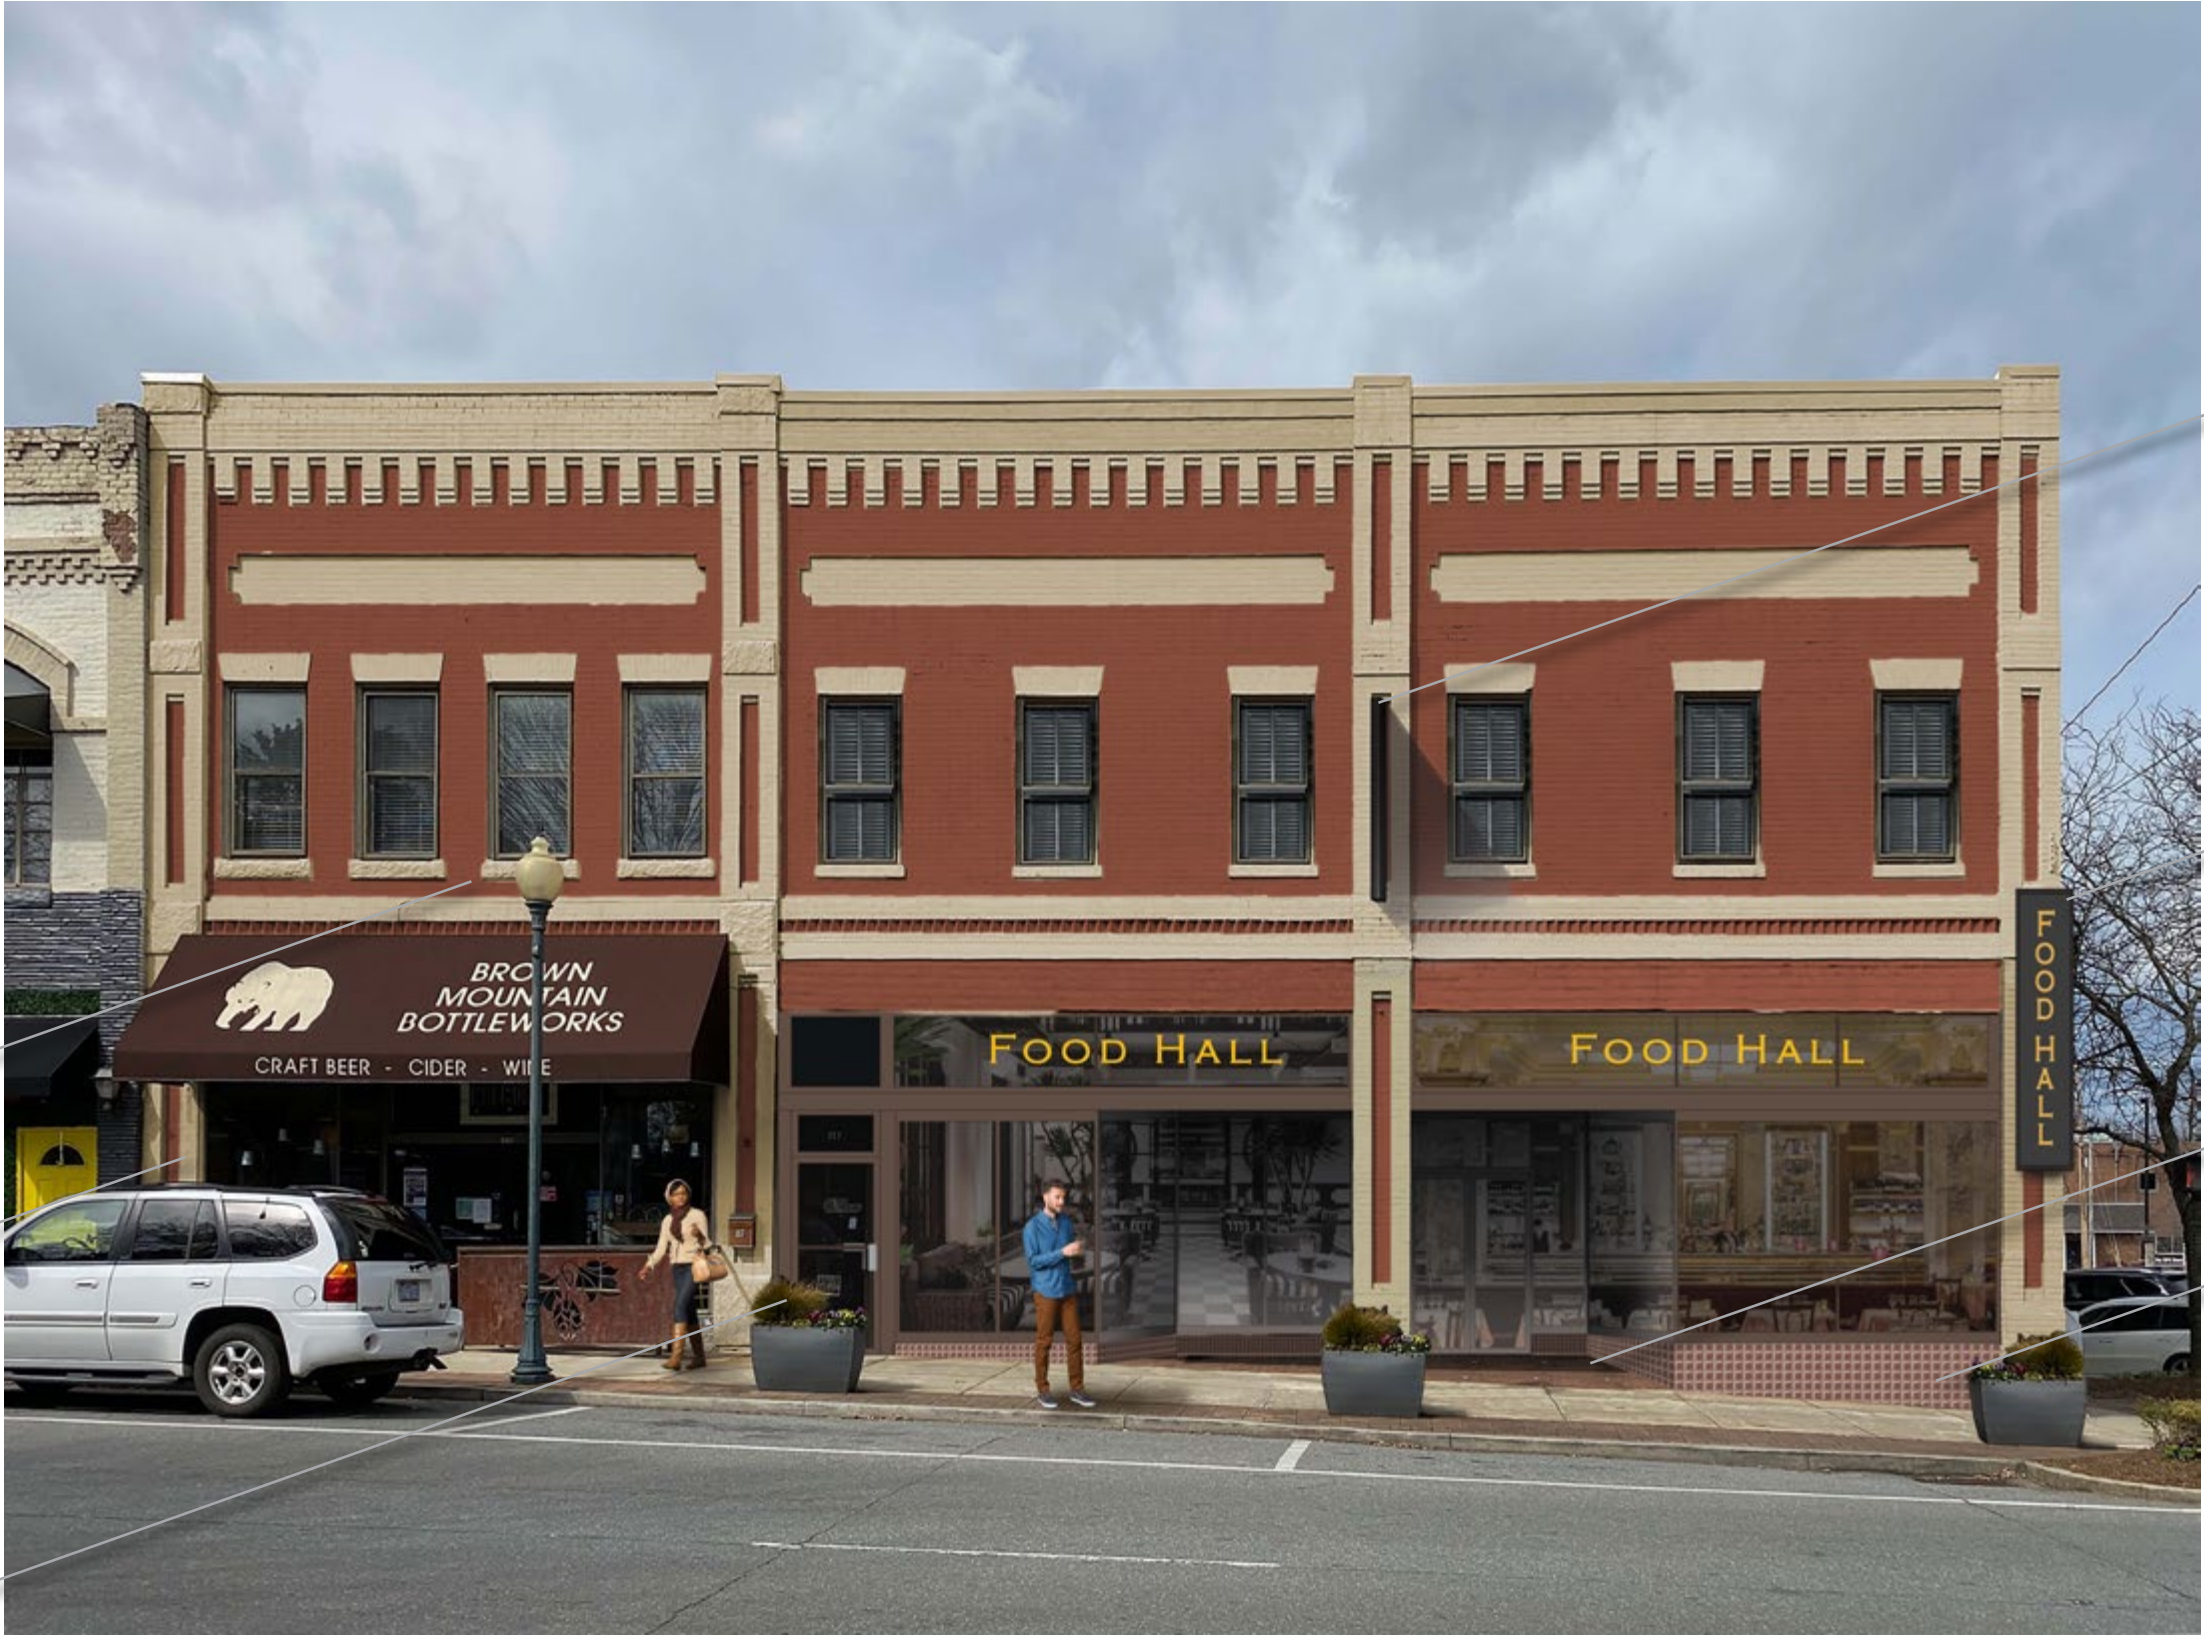
Design Scheme 2

SW 2837 Aurora Brown	Brick Body of Facade
SW 2822 Downing Sand	Brick Architectural Features
SW 2808 Rookwood Dark Brown	Wooden Elements of Storefront
SW 2808 Rookwood Dark Brown	Wooden Window Surrounds and Sashes
