Hunting Creek Watershed Plan

Burke County, NC

February 2011

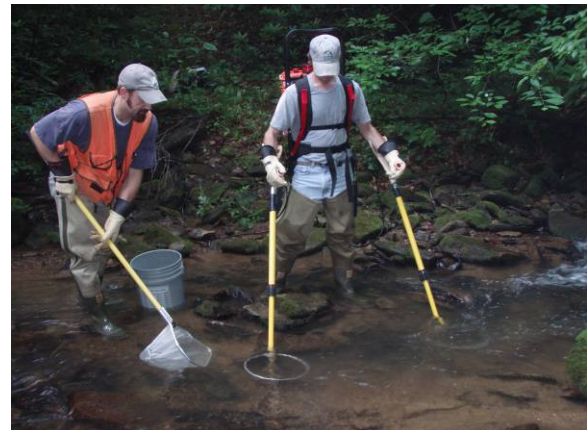
Equinox Environmental biologists collect fish from Hunting Creek.

Sampling methodology was based on the NCDWQ fish community assessment protocols (NCDWQ 2006b) and results were derived using the North Carolina Index of Biological Integrity (NCIBI). The NCIBI incorporates information about species richness and composition, fish abundance, age, and fish condition to summarize the effects of all classes of factors influencing aquatic communities.

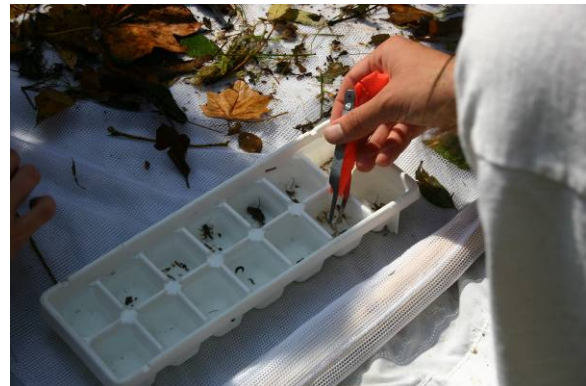
NCDWQ and NCEEP biologists collect and tally benthic macro invertebrates.

These invertebrates, which include aquatic insects, crustaceans, mollusks, and worms, are an important part of the aquatic ecosystem food chain, especially for fish. They are also an indicator of water quality since some macro invertebrates cannot live in polluted water while others thrive in such conditions.

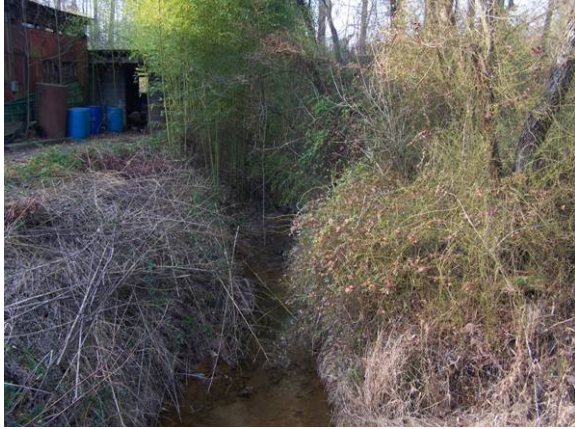
Physical stream features observed during the windshield survey reveal that all stream channels exhibit moderate incision. A channel is incised when water cannot escape the stream banks

Typical incised stream with riparian impacts from adjacent residence.

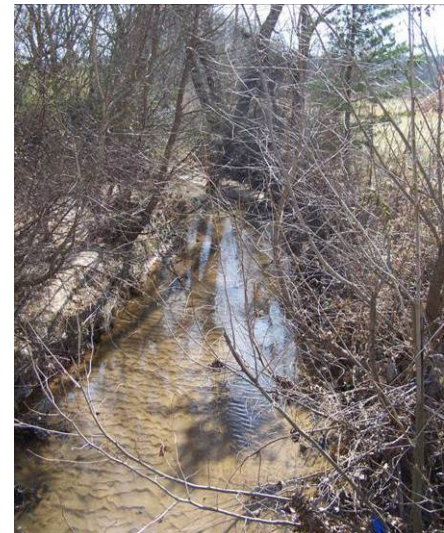
Sedimentation in Hunting Creek was observed to be heavy and widespread. Sand or silt substrate dominated with only a few areas in the watershed containing abundant coarse material typical of good fish habitat. Floodplain soil textures in the watershed are coarse and are more prone to stream bank collapse than finer textured soil (Connie Adams, Foothills Soil Consulting, Inc., personal communication). These coarse-textured floodplain soils are one factor that would lead to increased stream bank erosion. Therefore, in-stream sediment is likely originating from eroding stream banks that were also commonly observed during the windshield survey. Because of the excessive in-stream sedimentation, aquatic habitat including riffles, pools, and other features were extensively degraded.

Sandy substrate commonly observed in streams throughout the watershed.

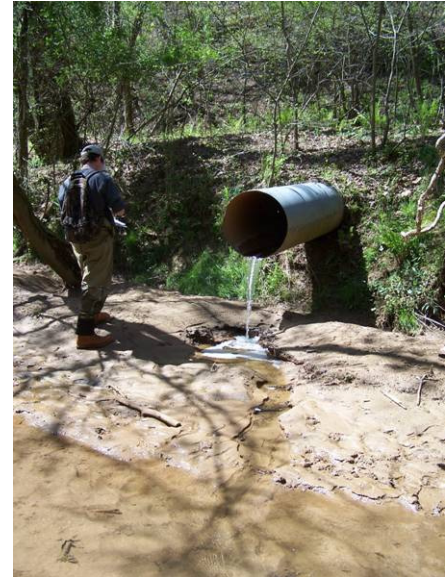
Outfall conductivity ranged from 17-995 $\mu\text{S}/\text{cm}$ with 86 $\mu\text{S}/\text{cm}$ being the median value. The land area draining to outfalls with conductivity readings greater than 200 $\mu\text{S}/\text{cm}$ were flagged to determine what may be contributing to the elevated conductivity readings upstream of the outfall. Table 3.6 shows the values and potential sources of red flagged conductivity readings. Figure 3.4 illustrates conductivity levels of all outfalls to Hunting Creek including the red flagged outfalls.

Pipe outfall entering Hunting Creek.

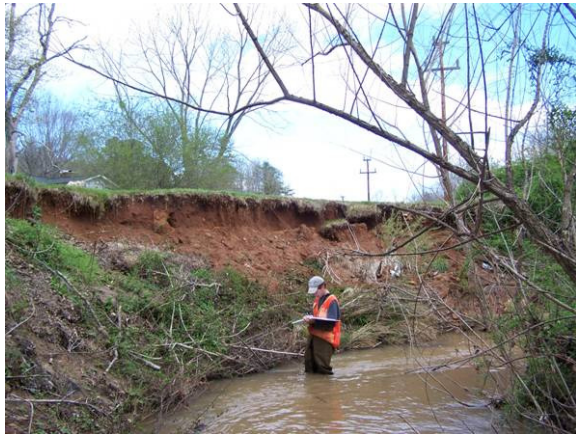
Although much of Hunting Creek’s stream banks exhibit some erosion, only sites with severe and active erosion were documented during the stream walk. Eroding stream banks varied from 6-13 feet in height and 25-100 feet in length. The width of woody riparian vegetation was less than 10 feet on one or both banks at all erosion sites. Coarse-textured loamy soils present throughout floodplains in the Hunting Creek Watershed are more susceptible to bank collapse, especially without riparian vegetation holding it in place. Eroding stream banks are a significant source of sediment input to streams.

Erosion site along Hunting Creek.

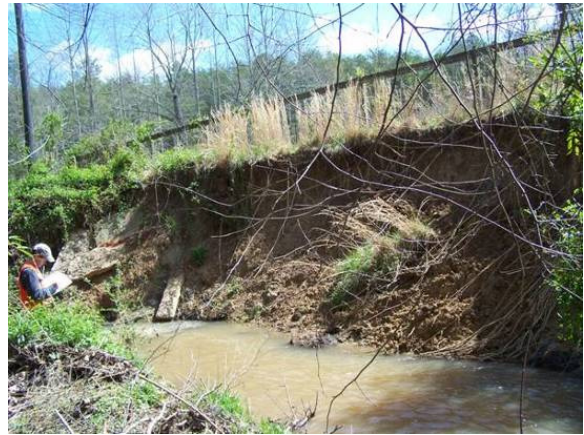
Erosion site along Hunting Creek.

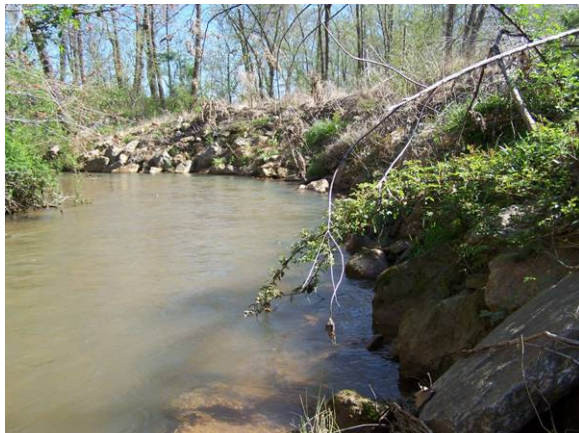
Recent modifications made to the stream channel from channel straightening or bank armoring from rip-rap, concrete, or other materials were recorded when encountered. Although the majority of streams in the Hunting Creek Watershed were likely straightened during the agricultural era of the early 1900’s, only modifications within the last 10 years were noted during the stream walk. Channel modification was only observed at three locations, which were all associated with stream bank armoring. Boulders, concrete slabs, and other hardscape materials were placed on the stream banks to prevent property loss from erosion. While this practice prevents localized erosion, it is often a temporary fix that displaces and exacerbates erosion to a downstream location.

Bank armoring with rip rap along Hunting Creek.

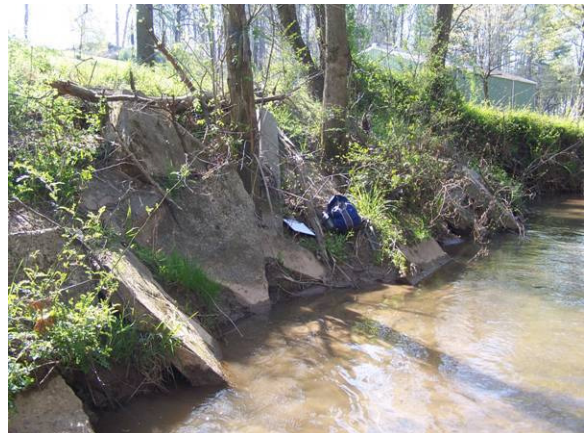
Bank armoring with large concrete slabs along Hunting Creek.

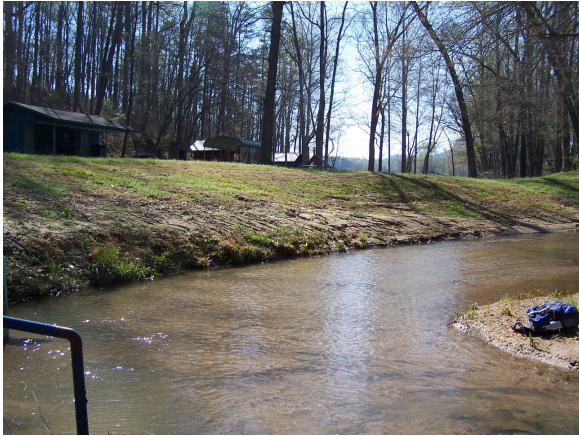
Riparian areas were often found to be degraded due to lack of woody vegetation and soil disturbances. Utility right-of-ways such as sewer pipes and electrical power lines often occur within the riparian area and require vegetation to be maintained to a minimum. Where woody vegetation in the riparian zone is disturbed, sediment and other pollutants are able to enter the stream. The average length of the 16 significantly disturbed riparian areas observed along Hunting Creek was 150 feet long and extended an average of 60 feet beyond the stream bank.

Lack of woody vegetation in the riparian area.

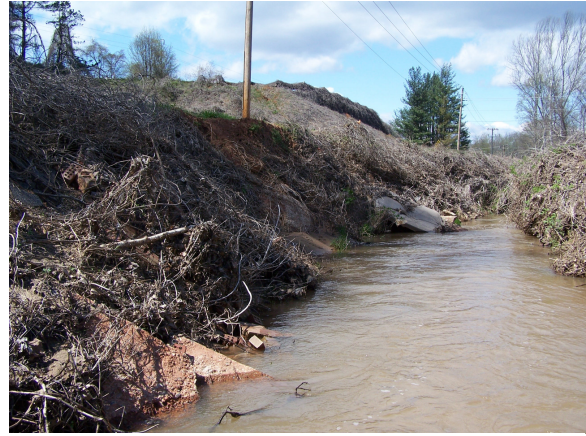
Large tree removal along the power line right-of-way parallel to stream impacting the buffer.

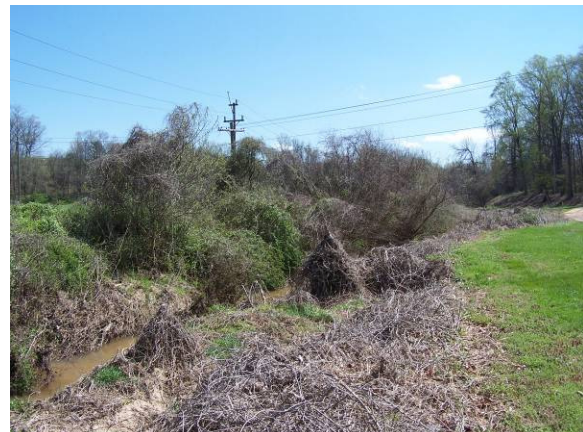
Power lines crossing Hunting Creek overhead.

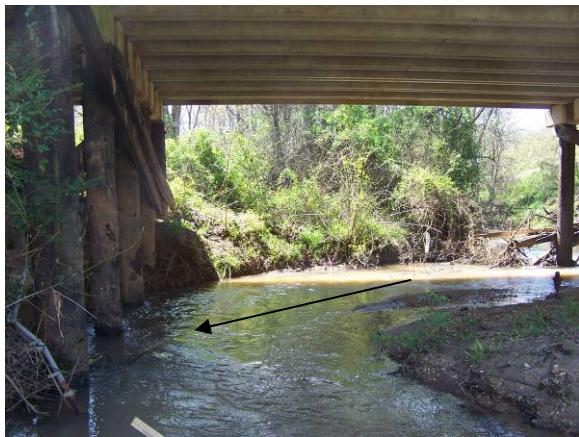
Bridges, culverts, dams, and other structures were recorded when they were observed to cross Hunting Creek. Four crossings are not aligned with the stream flow and were observed to be causing stream bank erosion near and around the structures' footings. Two crossings, including a relic dam and a hanging culvert, pose barriers to fish movement. Another concern identified at several structural crossings was bank scour and erosion on the upstream and downstream side of the crossing.

Bridge crossing not aligned with flow of stream (As indicated by arrow) causing stream bank erosion.

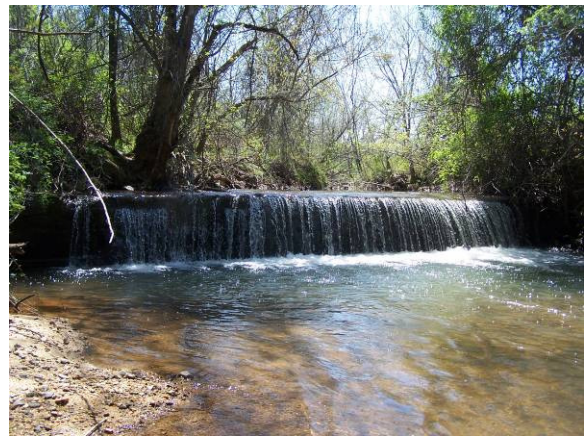
Relic dam creating a barrier to fish migration.

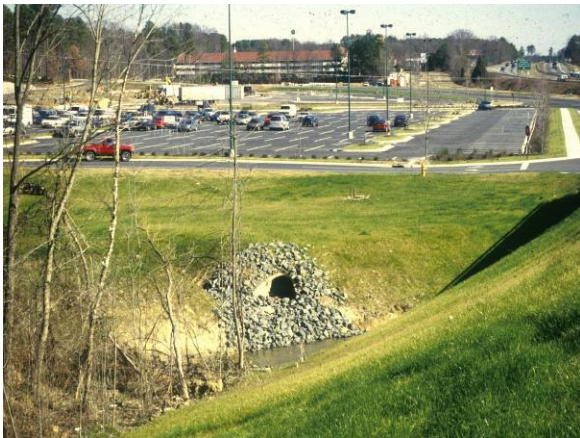
Stormwater management in the Hunting Creek Watershed, like most stormwater systems in the region, is designed to remove water from a site as quickly as possible through a network of underground pipes. Stormwater runoff is received through storm drain grates located in roads and parking lots and is then routed through an underground series of pipes to an outfall. Outfalls release stormwater directly into streams. This type of system does not treat or remove pollutants that reside on impervious surfaces. Furthermore, concentrating the flow of runoff increases the volume and velocity of stormwater into the stream, which often leads to stream bank erosion and increased sedimentation in waterways.

Stormwater running off parking lots is directed to the stream channel through a series of storm drains, underground pipes, and outfalls.

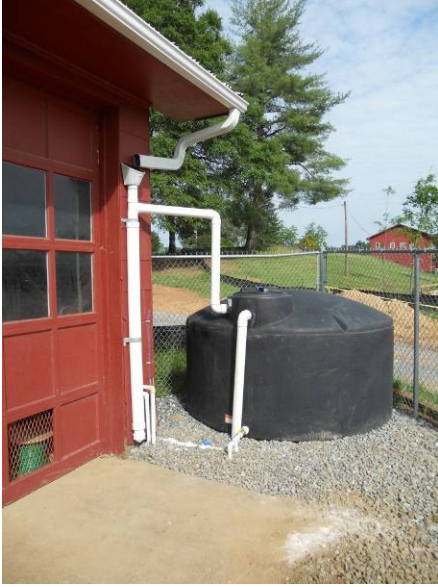
An above ground cistern located at the City of Morganton Parks and Recreation maintenance building catches runoff from the roof. The high pressure water is used to clean equipment.

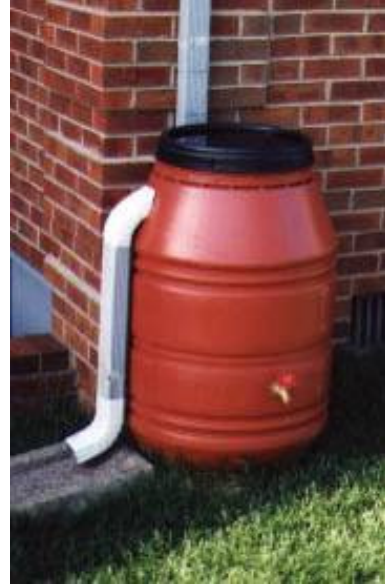
A rain barrel is attached to a downspout and collects rain water.

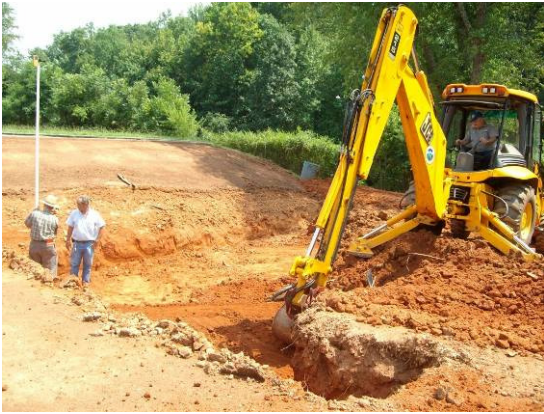
A depression is being dug for the installation of a bio-retention area at Gene Turner Park in Morganton outside the Hunting Creek Watershed.

Gene Turner Park is a 2.3 acre city park located in central Morganton outside the Hunting Creek Watershed. It contains two ball fields, two batting cages, a field house, and approximately a half acre of impervious surfaces. In 2009, a rain garden was installed to capture and treat stormwater runoff from the parking lot and adjacent road. The highly visible rain garden also serves to educate the public about stormwater and demonstrates how best management practices function. The project was funded by a grant from the Environmental Protection Agency and was a collaborative effort between the City of Morganton, Burke County Soil and Water Conservation, and Carolina Land and Lake Resource Conservation and Development Council. The following photos exhibit the installation of the rain garden.

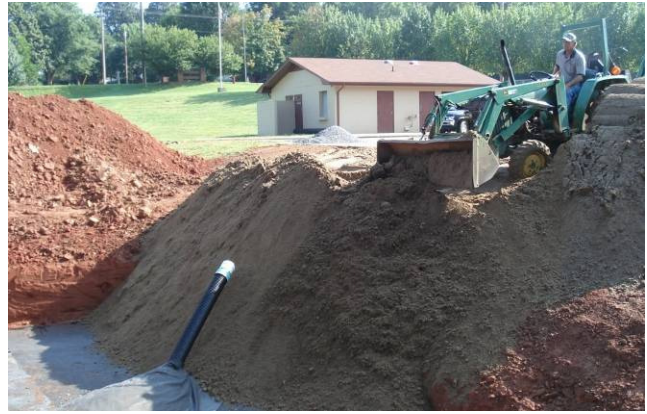
The depression is filled with a soil medium that allows water to slowly infiltrate into the ground while removing pollutants through filtration.

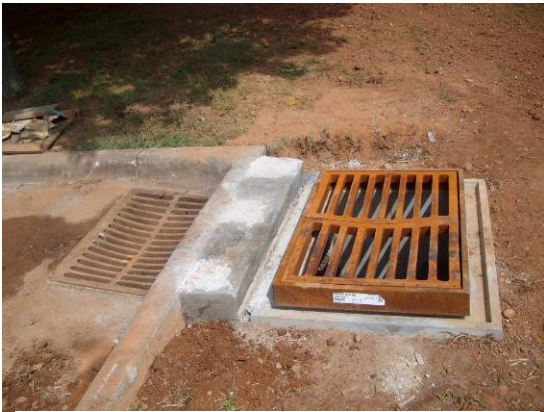
Water from the parking lot flows into a storm grate....

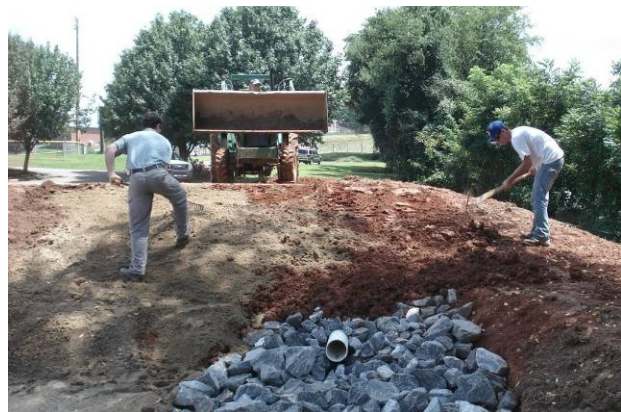
...and enters the bio-retention area through an underground pipe.

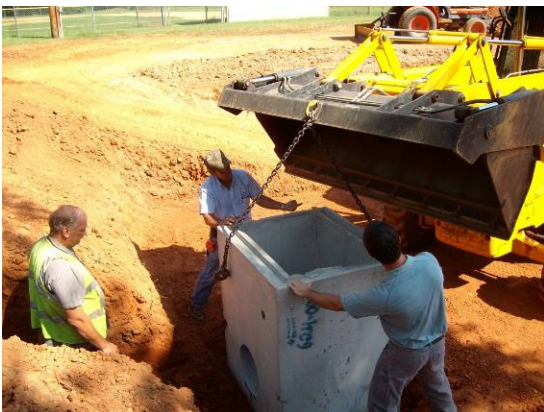
A stand pipe is placed within the bio-retention area to direct overflowing water back into the storm system in the event of large rainfall.

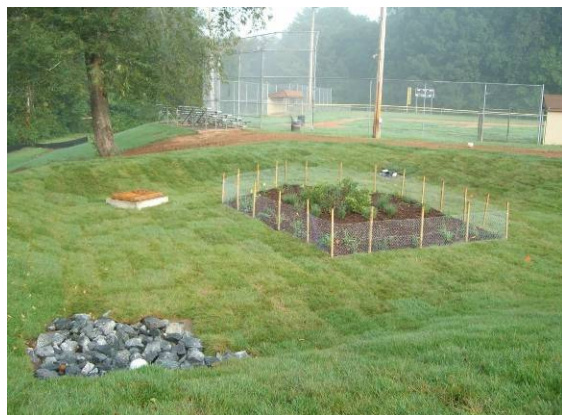
The bio-retention area is landscaped with vegetation that can withstand periodic fluctuations in water levels. It also adds to the aesthetics of the park.

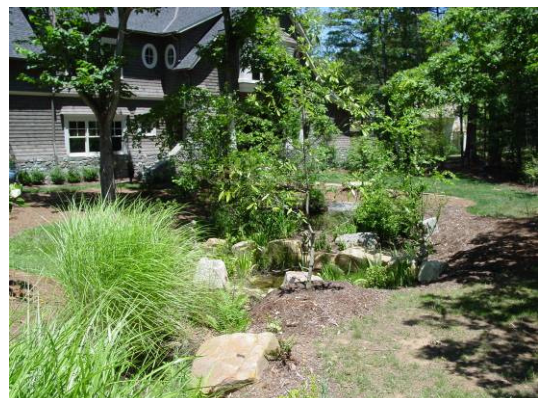
Same bio-swale as the image to the left shown 3 years after installation. In addition to treating stormwater runoff, the landscaping adds to the aesthetics of the site.

A bio-swale is another type of non-structural BMP. Here the bio-swale is shown immediately after construction. The rocks, plants, and mulch slow stormwater runoff and filter pollution before water enters the stream.

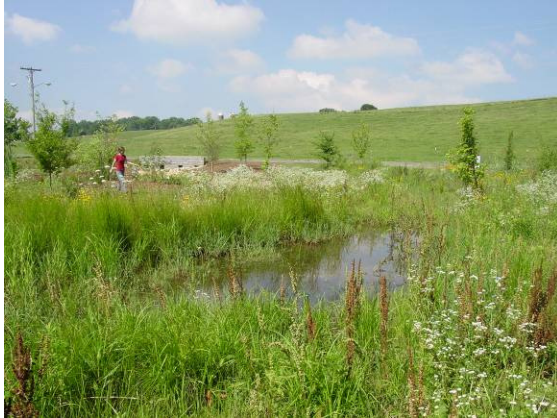
A constructed wetland at a city park captures stormwater runoff from a residential development and a parking lot. It also serves as a water feature in the park and provides wildlife habitat.

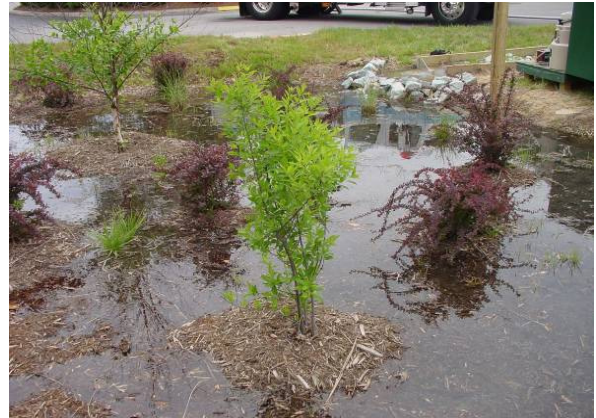
A bio-retention area effectively captures runoff, preventing large volumes of polluted runoff from entering a stream.

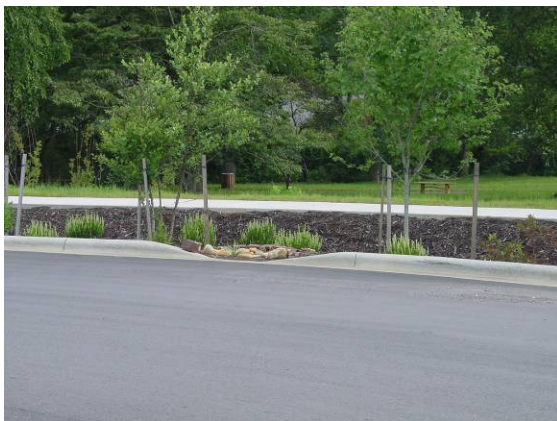
A small curb cut allows stormwater from a parking lot to enter into a bio-retention area bordering the parking lot.

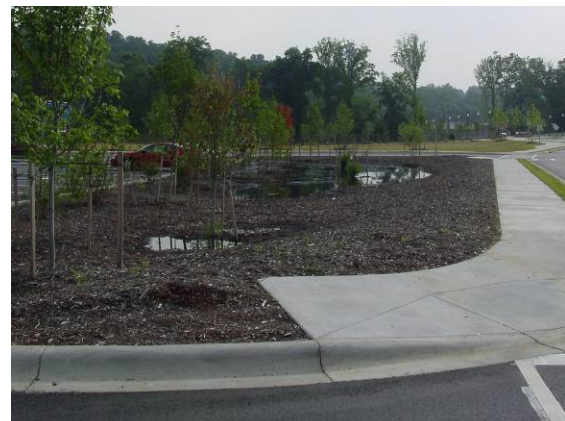
Following a rain event, stormwater enters the bio-retention area where it is absorbed by mulch and soil and is taken up by plants.

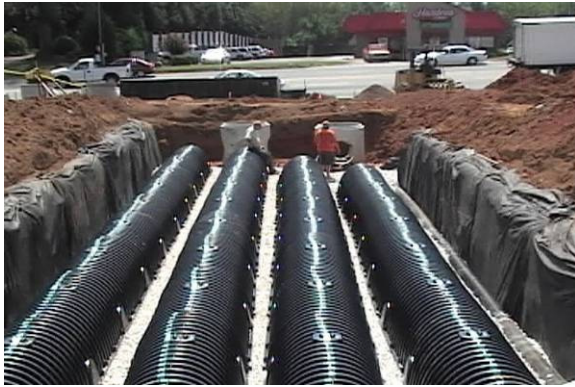
Filtration chambers are installed during construction of the Bojangles parking lot in Morganton (outside the Hunting Creek Watershed). The chambers will capture stormwater and filter it through a sand and stone medium before releasing it to a nearby stream.

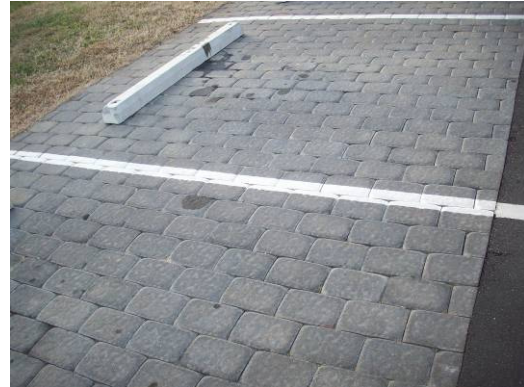
Permeable pavers are installed in the parking lot of Willow Ridge Apartments in Morganton. Stormwater carrying pollutants will infiltrate through the pavers rather than washing off into nearby waterways.

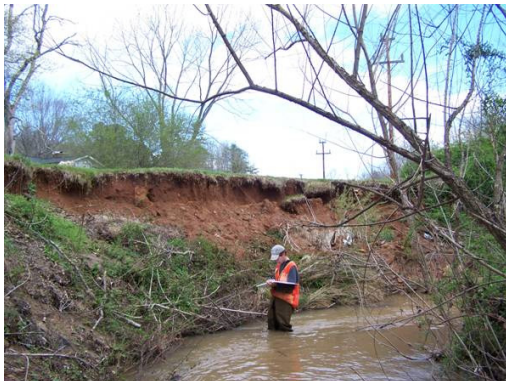
Eroding stream bank along Hunting Creek lacking woody riparian vegetation.

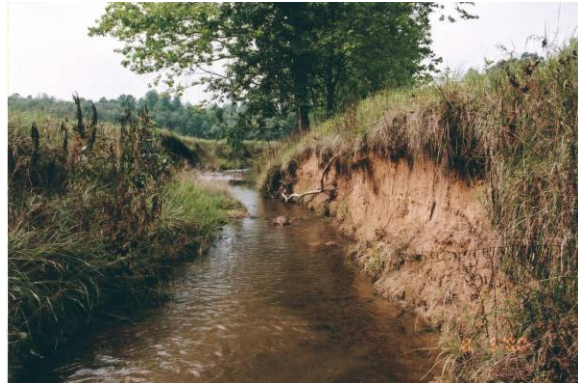
Bob's Creek, an eroding stream in the Muddy Creek Watershed that underwent stream restoration.

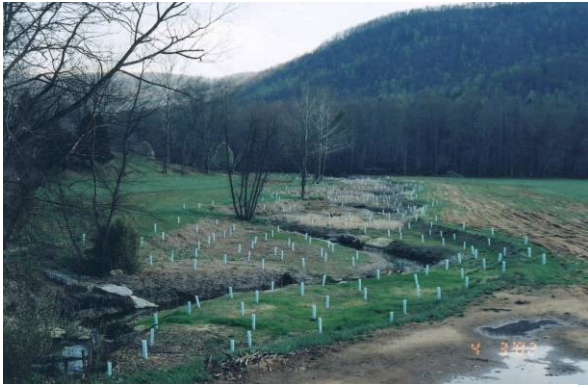
Bob's Creek with reestablished channel dimension and pattern and planted riparian area.

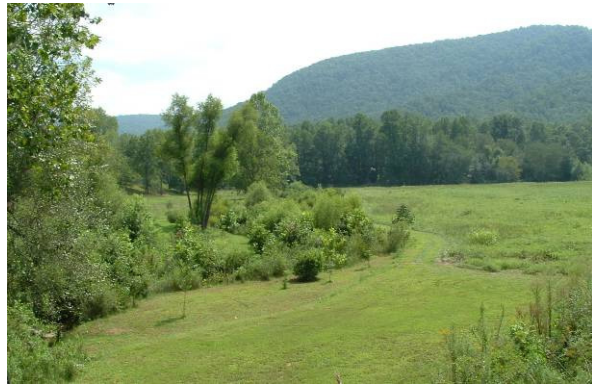
Bob's Creek with established riparian vegetation.

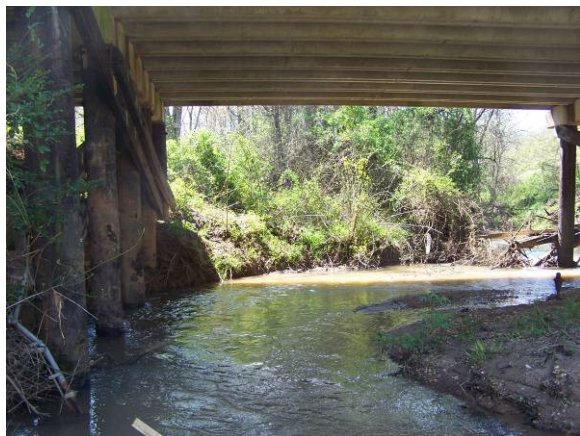
Bridge crossing not aligned with flow of stream causing stream bank erosion.

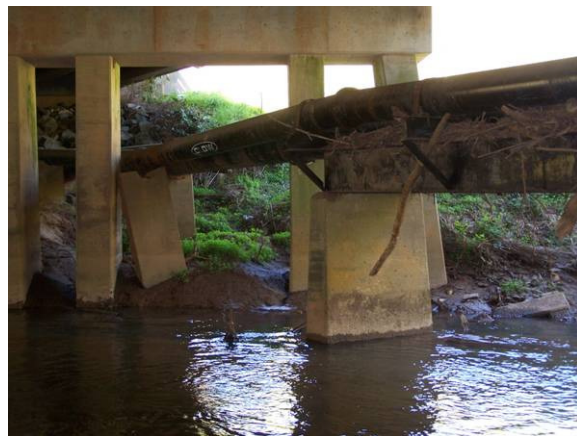
Pipe utility crossing Hunting Creek under US-70 bridge. Note dislodged footer causing sag in pipe at joint.

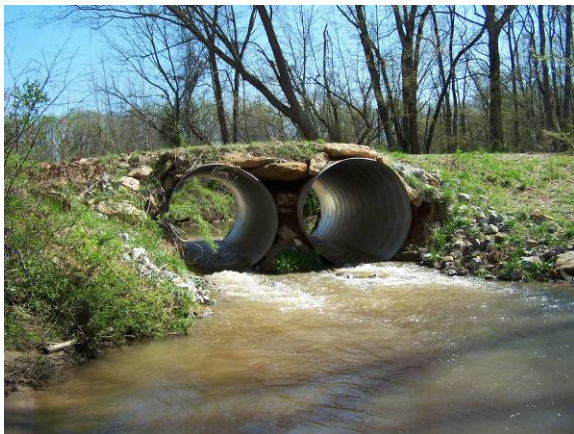
Structural crossing with double culverts creating a barrier to fish migration.

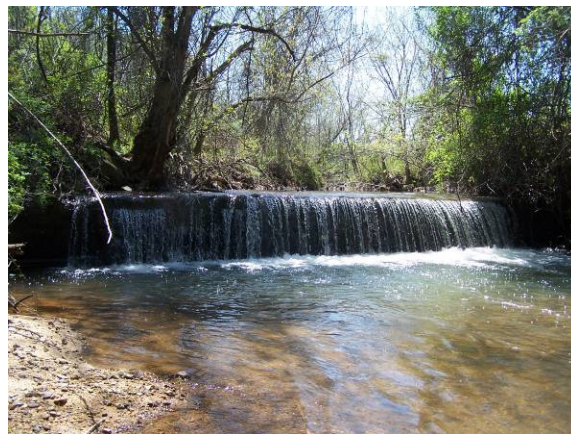
Low head dam in Hunting Creek creating a barrier to fish migration.

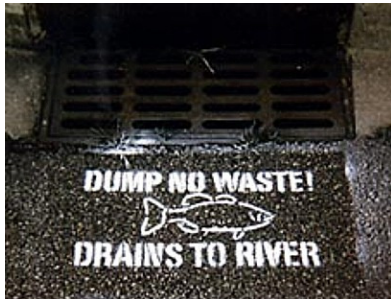
Stenciling on a storm drain lets the public know where stormwater goes.

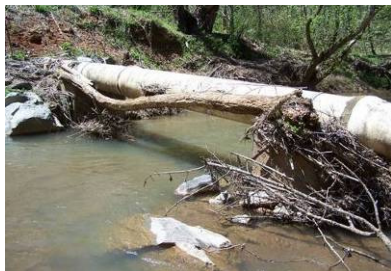
Pipe utility crossing Hunting Creek above stream with debris pile behind pipe. Also note erosion along stream bank

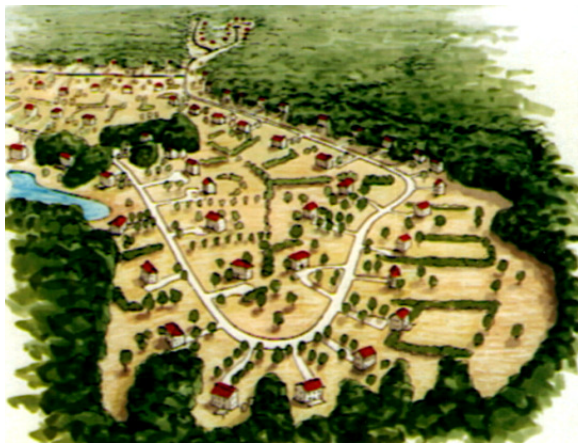
Traditional development patterns perpetuate sprawl.

Smart Growth concentrates development in the city center while Low Impact Development is development or re-development that minimizes imperviousness and maintains pre-development hydrology through stormwater management and open space preservation. Consistent with Morganton’s Mission 2030 Plan (City of Morganton 2010), redevelopment and development of industrial, commercial, and institutional districts should occur as infill development and should not be expanded to include additional undeveloped land area. Furthermore, the 2030 plan states “Residential subdivisions should be encouraged to be cluster developments to preserve tree cover and open space...” To encourage this type of development, programs such transfer of development rights, density bonuses, and other subsidies should be available as incentives.

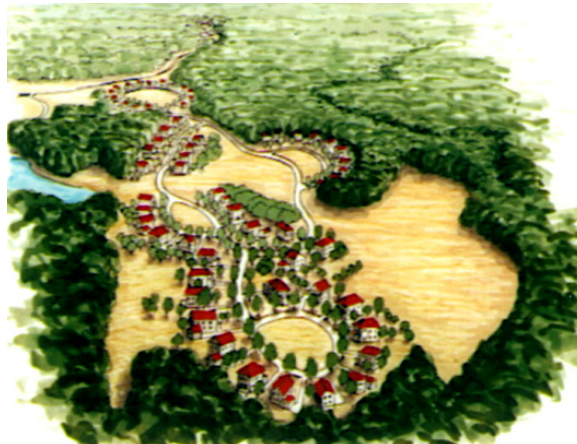
Cluster development patterns protect open space and character while protecting water resources.

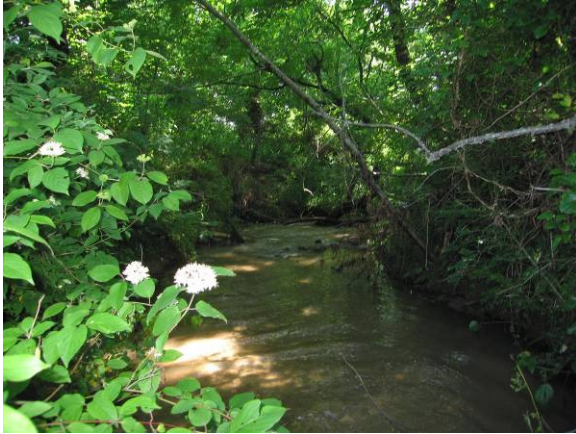
Hunting Creek at SR 1950 (Poteat Road)

This site is located in the Hunting Creek headwaters, upstream of most of the development. There is agriculture in the catchment representing crops and farm animals. Based on the taxa collected and using the small stream rating methodology (NCDWQ 2009), this site received an Excellent bioclassification. Twenty-six EPT taxa were collected, including five stone fly taxa. Fifteen mayfly taxa were collected, which is double the number of any of the other Hunting Creek drainage sites. Seven of the mayfly taxa were in the Baetidae family, which feed mostly by

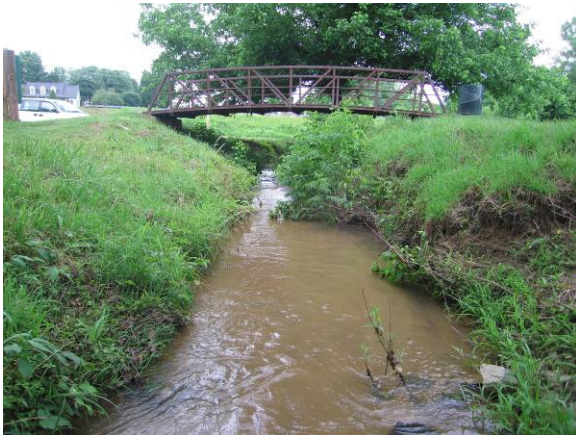
Fiddlers Run is the largest tributary to East Prong Hunting Creek, which is in turn, a main tributary to Hunting Creek. The upper portion of Fiddlers Run is located in a less developed watershed, but the lower portion flows through the urban watershed of Morganton. The sampling location was located in a city park in Morganton just upstream of the confluence with East Prong Hunting Creek. The drainage area of Fiddlers Run is practically the same as Hunting Creek at Poteat Road (2.45 versus 2.5 square miles). Based on the taxa collected and using the small

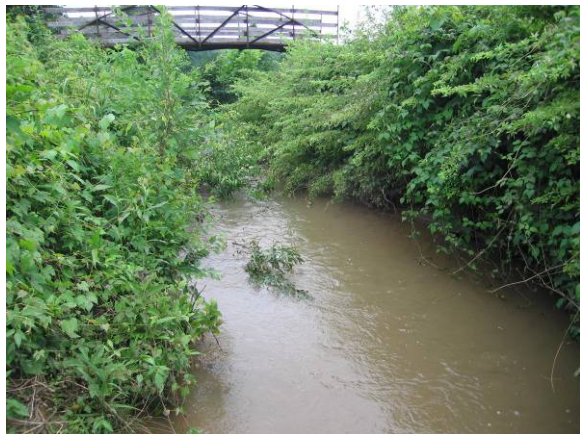
East Prong Hunting Creek is a large tributary to Hunting Creek and has a drainage area of 6.5 square miles. Based on the EPT taxa collected, E. Prong Hunting Creek received a Good-Fair bioclassification. Sixteen EPT taxa were collected, including eight mayfly taxa, two stonefly taxa, and six caddis fly taxa. Most of the taxa collected were moderately tolerant. If the Biotic Index had been used to derive the bioclassification rather than just the EPT taxa, the rating would have been Good. The EPT abundance, EPT biotic index, and the NC BI are very similar for Fiddlers Run and

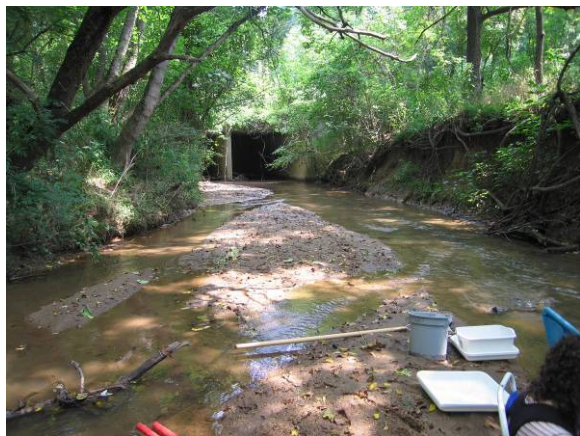
At this location on Hunting Creek, the drainage area is 8.9 square miles. The fewest EPT taxa (10) were collected here and at Pee Dee Branch (10). This site received the lowest bioclassification (Fair) of the seven sites. Hunting Creek at Bethel Road had the highest EPT BI (5.69) and the highest NC BI (6.26) indicating the most tolerant benthic community of all the sites. The specific conductance was the highest at this site (96 $\mu\text{mhos/cm}$). From the uppermost site on Hunting Creek at Poteat Road to the Bethel Road site, the benthic community and the water quality

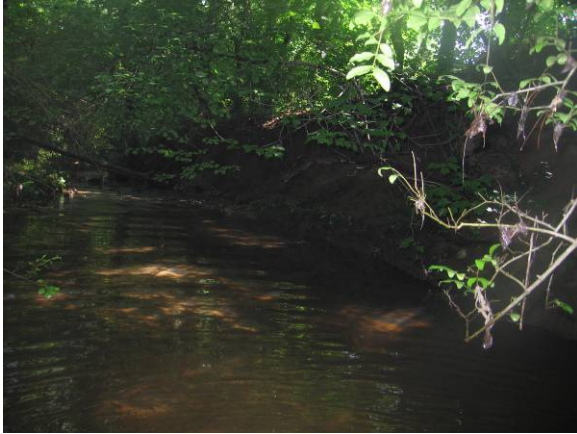
Pee Dee Branch is a small urban tributary that flows through the City of Morganton. Ten EPT taxa were collected. This was the only site where no stoneflies were collected. Using the small stream criteria (NCDWQ 2009), Pee Dee Branch received a Good-Fair bioclassification. A high number (27 individuals) of the midge, *Chironomus* were collected and approximately half were mounted and observed for signs of mentum deformity, which is an indication of toxicity (Lenat 1993). No deformities were noted upon inspection. *Chironomus* is very tolerant and is an indicator species of nutrient enrichment. Another midge taxa that is very tolerant and considered an indicator of toxicity, *Thienemannimyia* gr. was abundant at this site. It is interesting that this is the only site where the caddisfly, *Dolophilodes* was collected. *Dolophilodes* is a filter feeder and is considered relatively intolerant. The NC BI (5.50) was the second highest after the Hunting Creek Bethel Road site.

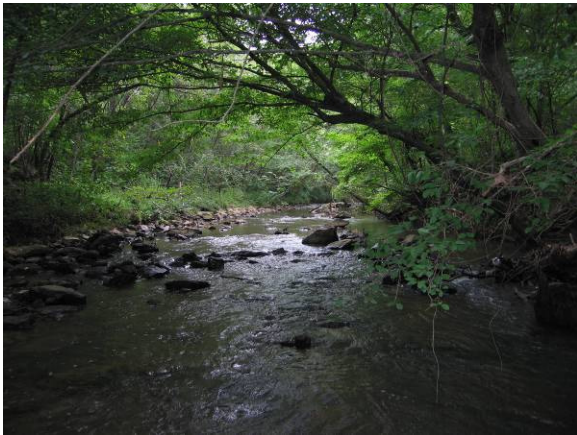
The drainage area at this site is 25 square miles and captures most of the Hunting Creek watershed before it enters the Catawba River. Fifteen EPT taxa were collected, including seven mayfly taxa, one stonefly taxa, and seven caddisflies. Like the Hunting Creek Bethel Road site, only one individual stonefly was collected, which is low for a stream that encompasses such a large drainage area. This site received a Good-Fair bioclassification. The EPT BI and the NC BI were both lower at this site than the Hunting Creek Bethel Road site, which is located in the mid portion of the drainage. The lower numbers indicate some improvement in the benthic community in Hunting Creek downstream from the Bethel Road site. Several taxa were collected only here and at the comparison site, Stacey Creek. These were *Rhyacophila fuscata*, *Epeorus vitreus*, and *Maccaffertium pudicum*. This site scored the highest for habitat (84) and was noticeably less sandy than at Bethel Road. Although, the overall benthic fauna improved slightly from the Bethel Road site, the collection of only one individual stonefly at this site is an indication of water quality issues.

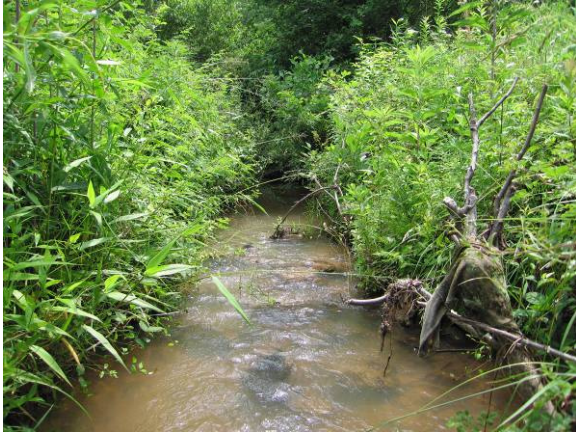
Stacey Creek at SR 1918 (Watershed Road)

Stacey Creek is a small tributary to Henry Fork, located just south of Morganton and the Hunting Creek watershed. Thirty seven EPT taxa were collected in this small stream. Based on the taxa collected and using the small stream rating methodology (NCDWQ 2009) for mountain streams, this site received an Excellent bioclassification. Nine different stone fly taxa were collected. Based on the taxa collected, the EPT abundance, EPT BI, NC BI, this site is clearly the least impacted and has the most intolerant benthic fauna of any of the seven sites.
